Ukiah Municipal Airport Pavement Management System

Prepared for
City of Ukiah

**Mead
& Hunt**
www.meadhunt.com

May 2018

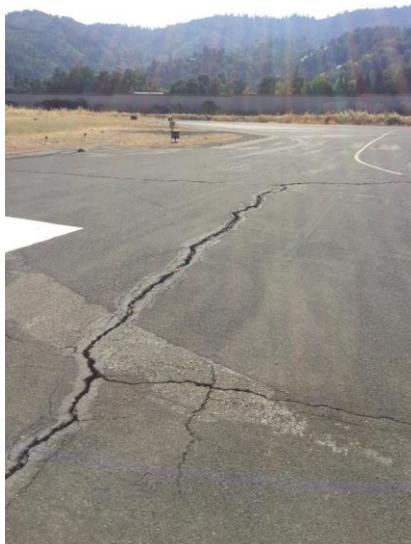
Severity	Distress (Sections 1 and 4)
Low	Longitudinal and Transverse Cracking
Medium	Weathering
High	Longitudinal and Transverse Cracking

Runway 15-33 (Section 4): Longitudinal and Transverse Cracking

The pavement on Runway 15-33 (Sections 1, 2, 3 and 4) is in poor-to-very poor condition. The pavement in this area exhibits several high-severity cracking issues, all attributable to thermal related and aging issues. Since no structural related cracking was observed during the visual inspection survey, a rehabilitation of Runway 15-33 is recommended to restore condition of the pavement. The recommended project will include milling the top 3-inches of AC, crack sealing, the placement of a 3-inch layer of new AC, and markings application. The estimated cost for this project is reported below:

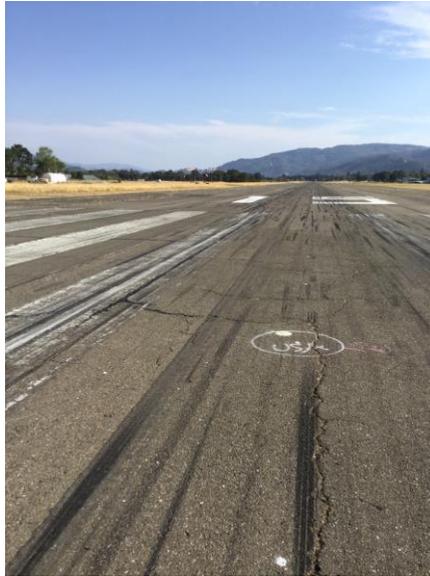
Severity	Distress (Section 2)
Low	Longitudinal and Transverse Cracking
Medium	Block Cracking, Weathering
High	Block Cracking, Longitudinal and Transverse Cracking

Runway 15-33 (Section 2): Block Cracking

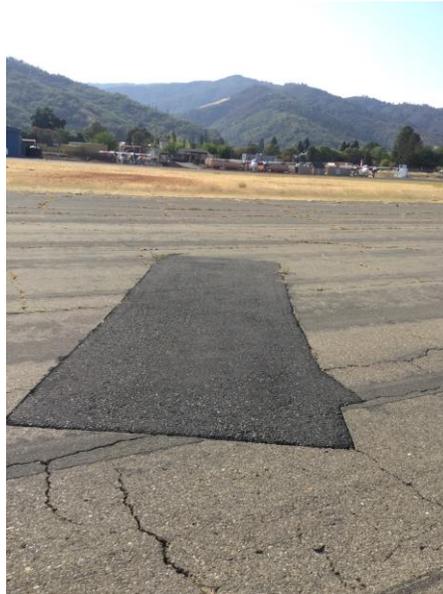
Severity	Distress (Section 3)
Low	Longitudinal and Transverse Cracking, Patching
Medium	Weathering
High	Longitudinal and Transverse Cracking

Runway 15-33 (Section 3): Patching

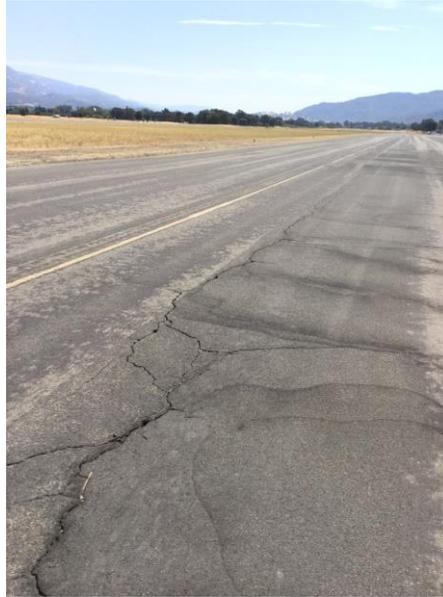
Severity	Distress (Section 5)
Medium	Alligator Cracking, Longitudinal and Transverse Cracking, Weathering

Parallel Taxiway A (Section 5): Alligator Cracking

The pavement on Taxiway A (Sections 5, 6, 7 and 8) exhibits thermal and aging related cracking, as well as localized structural related cracking. Although the pavement in this area is in fair-to-poor condition, the distresses observed do not show evidence of structural failure. For this reason, a rehabilitation of Taxiway A is recommended. The recommended project will include milling the top 2-inches of AC, crack sealing and pavement repair, the placement of a 2-inch layer of new AC, and markings application. The estimated cost for this project is reported below:

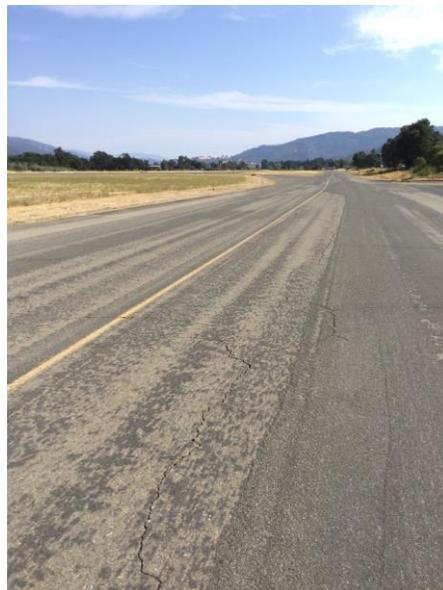
Severity	Distress (Section 6)
Medium	Longitudinal and Transverse Cracking, Weathering

Parallel Taxiway A (Section 6): Longitudinal and Transverse Cracking

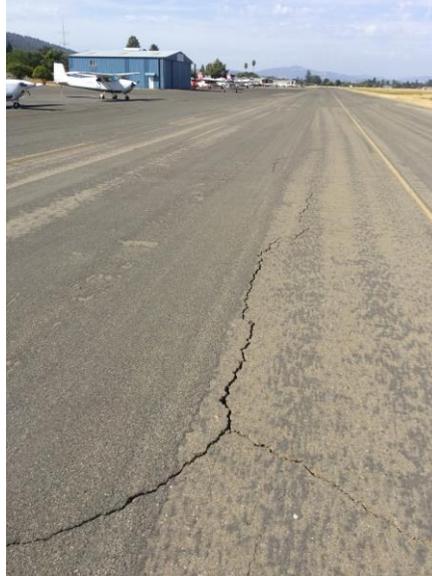
Severity	Distress (Section 7)
Low	Patching
Medium	Weathering
High	Longitudinal and Transverse Cracking

Parallel Taxiway A (Section 7): Longitudinal and Transverse Cracking

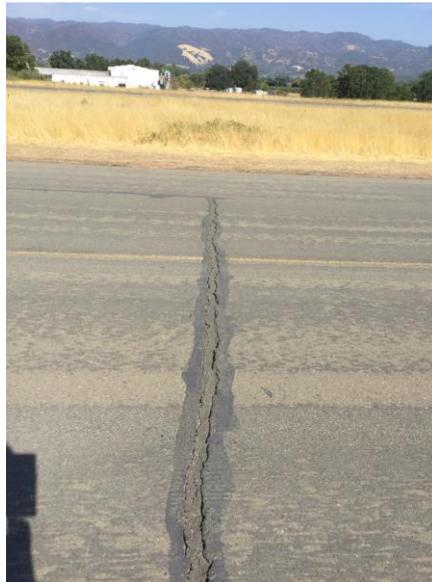
Severity	Distress (Section 8)
Medium	Weathering
High	Longitudinal and Transverse Cracking

Parallel Taxiway A (Section 8): Longitudinal and Transverse Cracking

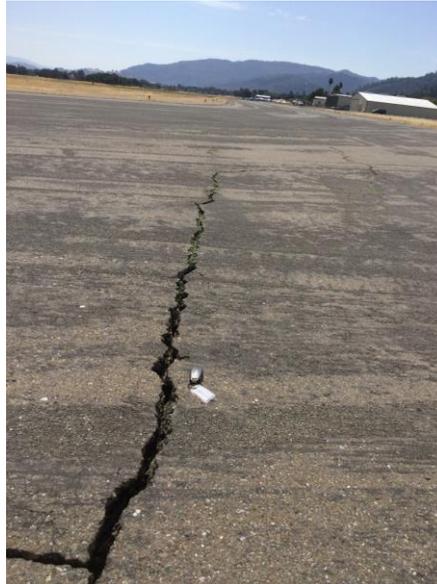
Severity	Distress (Section 9)
Low	Longitudinal and Transverse Cracking
Medium	Longitudinal and Transverse Cracking, Patching, Weathering
High	Longitudinal and Transverse Cracking, Weathering

Taxiway Connector B: Longitudinal and Transverse Cracking

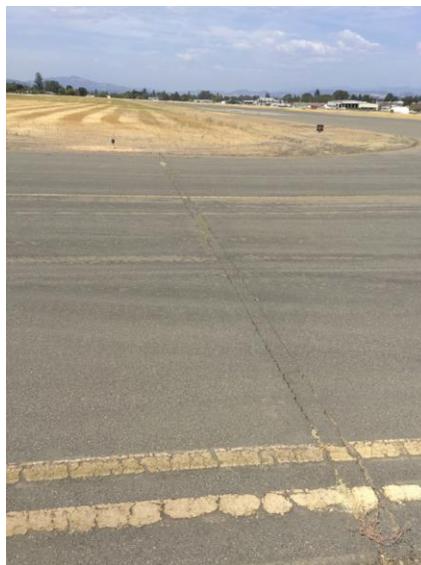
Severity	Distress (Section 10)
Low	Longitudinal and Transverse Cracking
Medium	Longitudinal and Transverse Cracking, Patching, Weathering

Taxiway Connector C: Patching

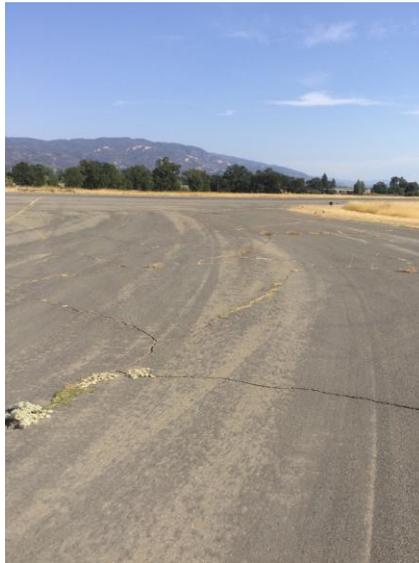
Severity	Distress (Section 11)
Medium	Weathering
High	Block Cracking, Longitudinal and Transverse Cracking, Patching

Taxiway Connector D: Longitudinal and Transverse Cracking

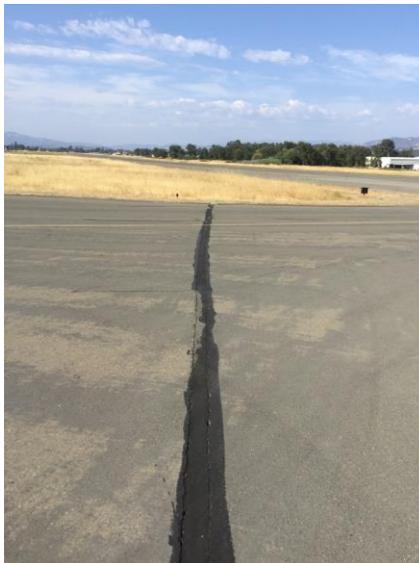
Severity	Distress (Section 12)
Low	Longitudinal and Transverse Cracking, Patching
Medium	Weathering

Taxiway Connector E: Patching

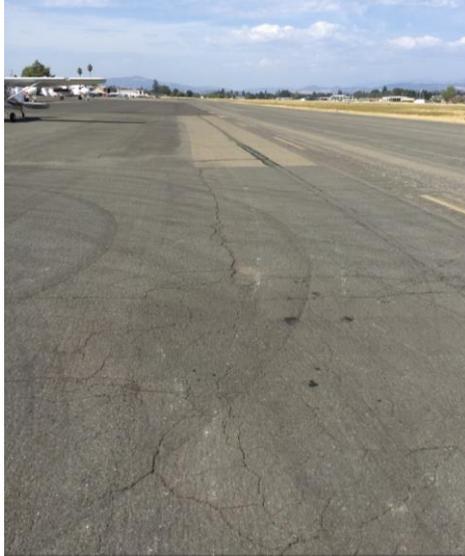
Severity	Distress (Section 13)
Low	Longitudinal and Transverse Cracking, Weathering
Medium	Alligator Cracking, Longitudinal and Transverse Cracking, Patching

Taxilane 1: Alligator Cracking

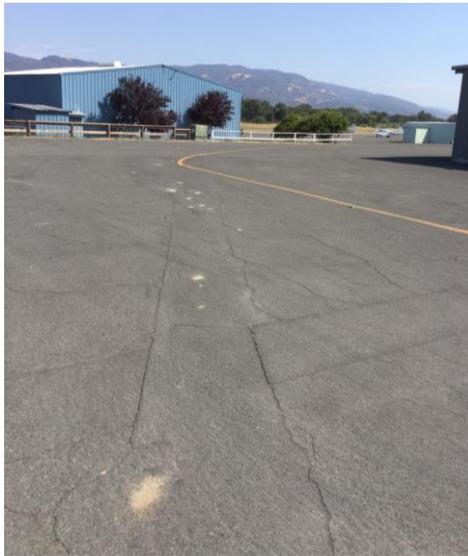
Severity	Distress (Sections 14 and 16)
Low	Block Cracking, Patching, Weathering
Medium	Block Cracking

Taxilane 2: Block Cracking and Patching

As part of a good maintenance practice, a rehabilitation of Hangar Area 1 Taxilanes (Sections 14 to 19) is recommended. Since the pavement did not show any sign of structural failure, but only age-related distresses, such as longitudinal and transverse cracking, block cracking, and weathering, a mill-and-fill is suggested as a possible rehabilitation treatment. The project includes milling the top 2-inches of AC, crack sealing, the placement of a 2-inch layer of new AC, and markings application. The estimated cost for this project is reported below:

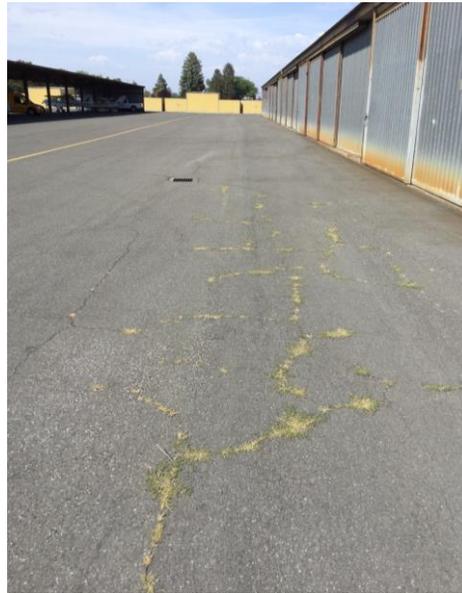
Severity	Distress (Sections 15, 17 and 18)
Low	Block Cracking, Weathering
Medium	Block Cracking

Taxilane 5: Block Cracking

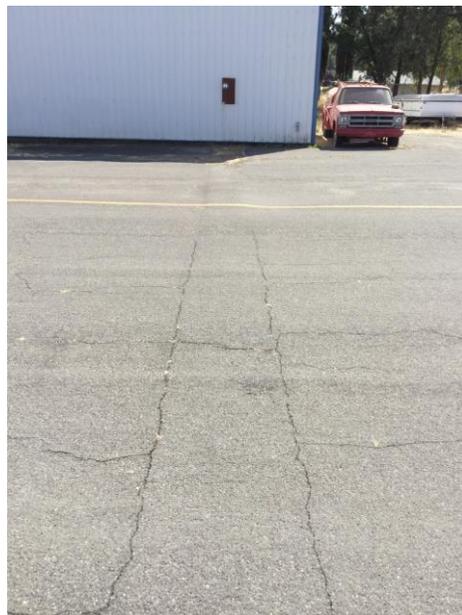
Severity	Distress (Section 19)
Low	Patching, Weathering
Medium	Block Cracking

Taxilane 7: Patching

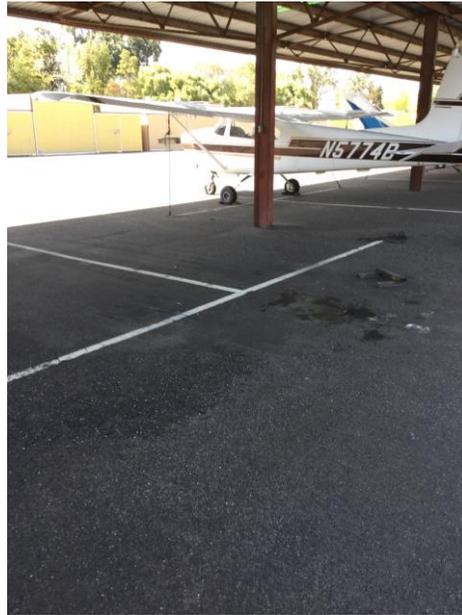
Severity	Distress (Section 20)
Low	Weathering

Shade Hangars: Weathering

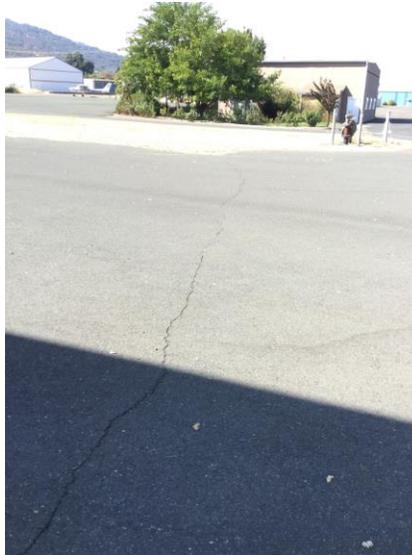
Severity	Distress (Section 21)
Low	Longitudinal/Transverse Cracking, Weathering
Medium	Longitudinal/Transverse Cracking

Hangar Area 2 Taxilane: Longitudinal and Transverse Cracking

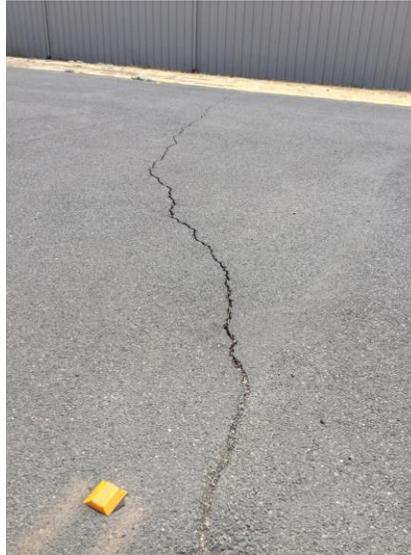
Severity	Distress (Section 22)
Low	Alligator Cracking, Longitudinal and Transverse Cracking, Weathering
Medium	Longitudinal and Transverse Cracking
High	Longitudinal and Transverse Cracking

Helipad Apron: Longitudinal and Transverse Cracking

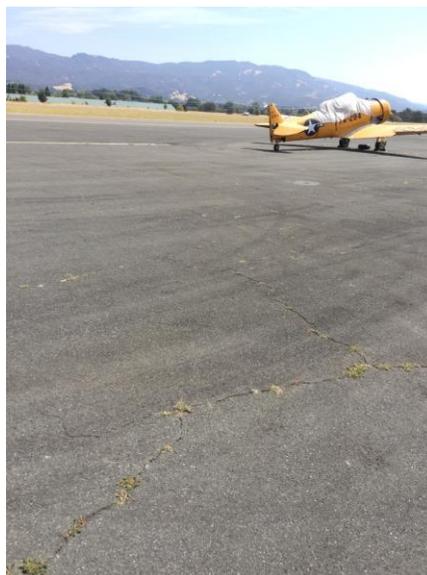
Severity	Distress (Sections 23)
Low	Longitudinal and Transverse Cracking, Weathering

Hangar Apron: Longitudinal and Transverse Cracking

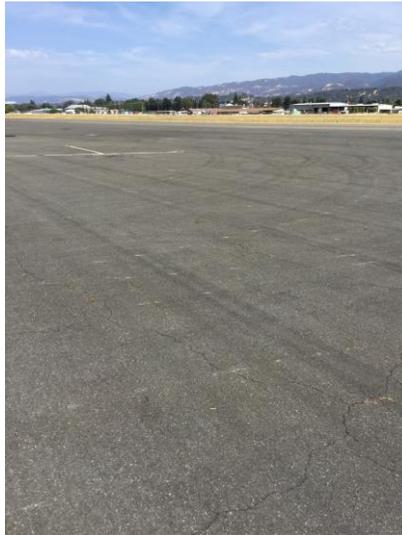
Severity	Distress (Section 24)
Low	Block Cracking, Weathering
Medium	Alligator Cracking
High	Alligator Cracking

Tie-Down Apron 1: Block Cracking

The AC pavement within Tie-Down Apron 1 (Section 24) and Tie-Down Apron 2 (Sections 26, 27, 28 and 29) is in poor-to-very poor condition and it is partially failed on Tie-Down Apron 2. Tie-Down Apron 2 includes also two PCC sections which condition ranges from fair to poor. The sections in these areas are severely affected by thermal and aging related cracking, as well as structural distresses. A reconstruction of these areas is recommended in order to maintain the structural capacity of the pavement. The project will consist of pulverizing the AC pavement and the suitable base, removing the PCC pavement, and placing 9 inches of AC (only 4 inches of AC if C130 is not part of the fleet mix) over 6 inches of AB. The AC will include 4 inches of surface layer and 5 inches of stabilized base. The existing PCC sections will be replaced by AC in order to decrease the cost of pavement maintenance. The estimated cost for this project is shown below:

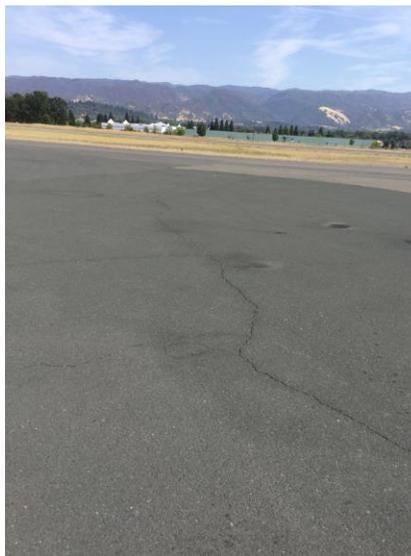
Severity	Distress (Section 25)
Low	Longitudinal/Transverse Cracking, Weathering

North Tie-Downs: Longitudinal and Transverse Cracking

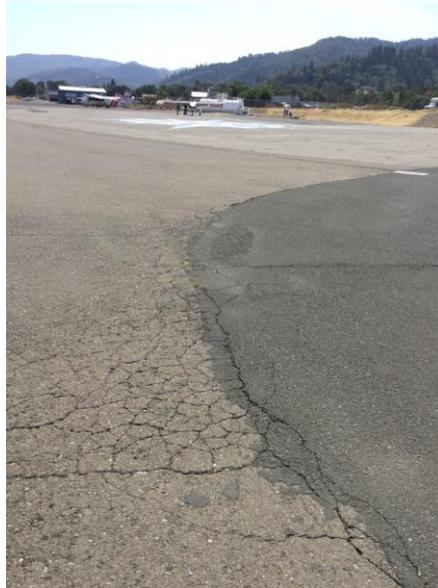
Severity	Distress (Section 26)
Low	Longitudinal and Transverse Cracking, Weathering
Medium	Block Cracking, Longitudinal and Transverse Cracking, Patching, Weathering
High	Alligator Cracking

Main Section AC 1: Alligator Cracking

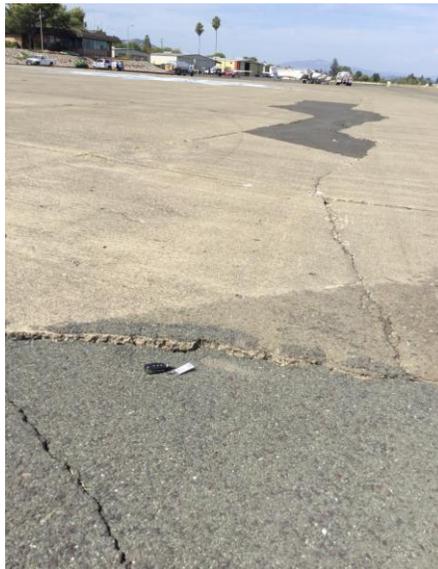
Severity	Distress (Section 27)
Low	Corner Break, Linear Cracking, Patching, Joint Spalling, Alkali Silica Reaction
Medium	Linear Cracking
High	Patching

PCC Section 1: Linear Cracking and Patching

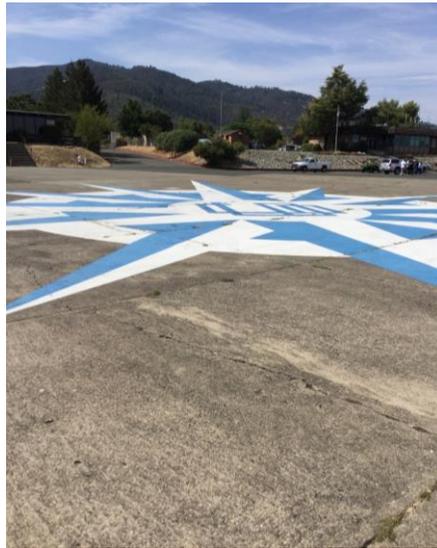
Severity	Distress (Section 28)
Low	Corner Break, Linear Cracking, Alkali Silica Reaction

PCC Section 2: Linear Cracking

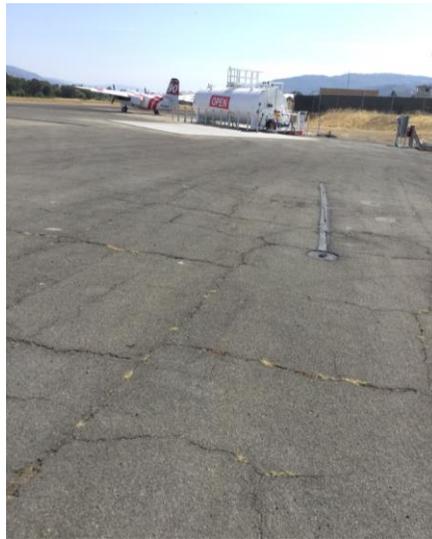
Severity	Distress (Section 29)
Medium	Patching, Weathering
High	Alligator Cracking, Block Cracking, Depression

Main Section AC 2: Block Cracking

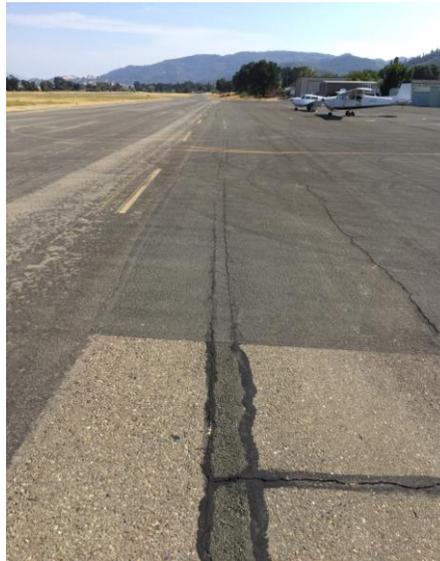
Severity	Distress (Section 31)
Low	Block Cracking
Medium	Block Cracking, Patching, Weathering

Tie-Down Apron 3: Patching

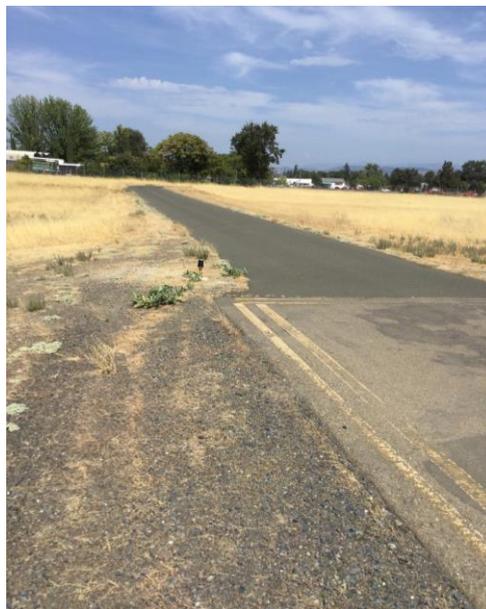
Severity	Distress (Section 32)
Low	Weathering
Medium	Depression

North Service Road 1: Depression

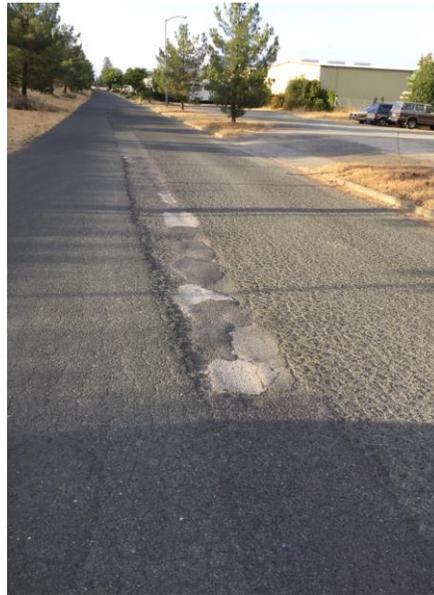
Severity	Distress (Section 34)
High	Weathering

West Service Road 1: Weathering

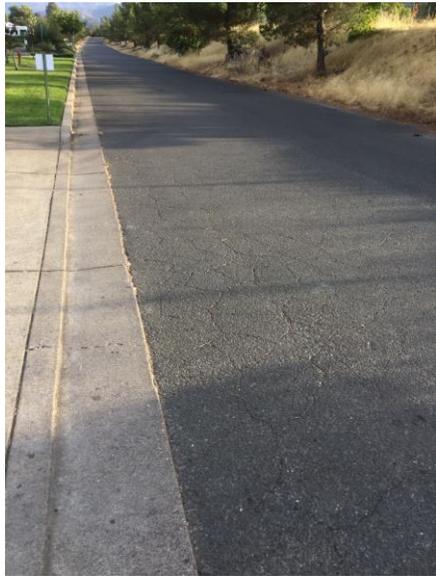
Severity	Distress (Section 35)
Low	Weathering
Medium	Alligator Cracking

West Service Road 2: Alligator Cracking

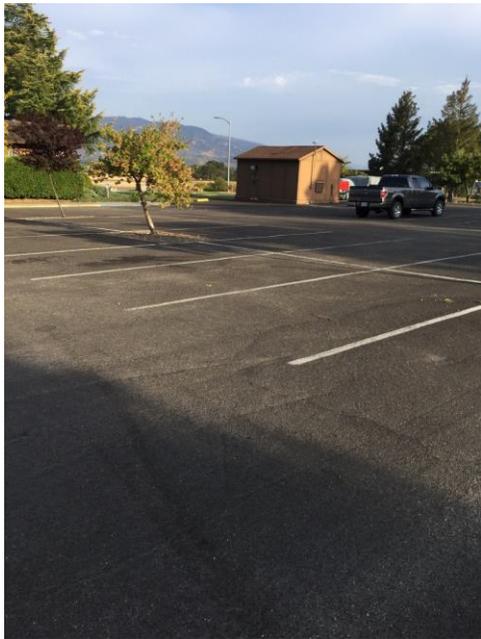
Severity	Distress (Section 36)
Low	Longitudinal and Transverse Cracking, Weathering

Parking Lot: Weathering
