Ukiah Municipal Airport Pavement Management System

Prepared for
City of Ukiah

**Mead
& Hunt**
www.meadhunt.com

May 2018

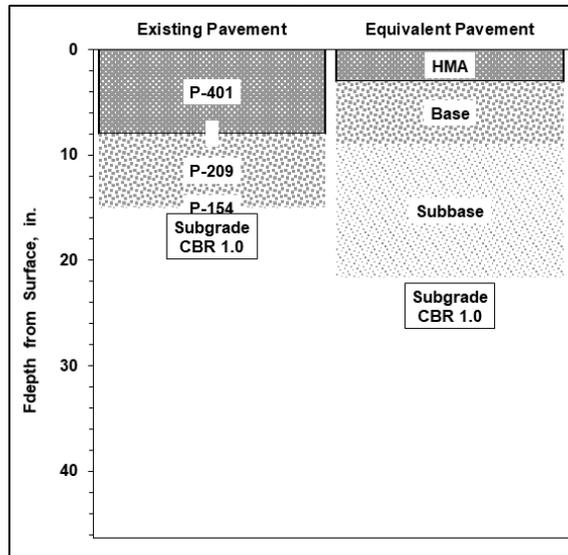
Runway 15-33

Existing Pavement Section

8 inch asphalt surface layer
7 inch aggregate base layer
Subgrade CBR 1

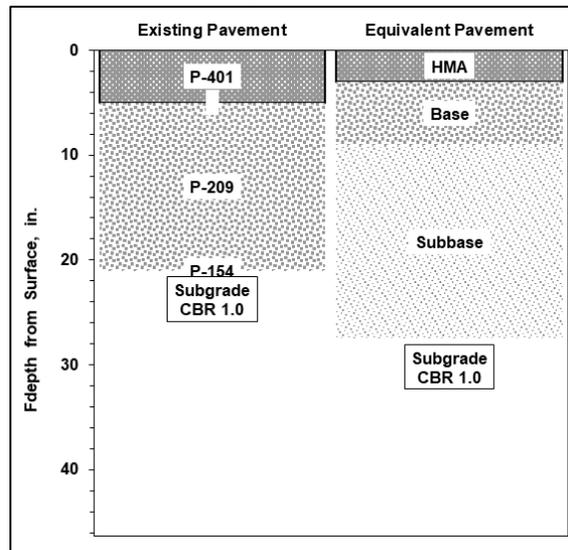
Taxiway Connector C

Existing Pavement Section

5 inch asphalt surface layer
16 inch aggregate base layer
Subgrade CBR 1

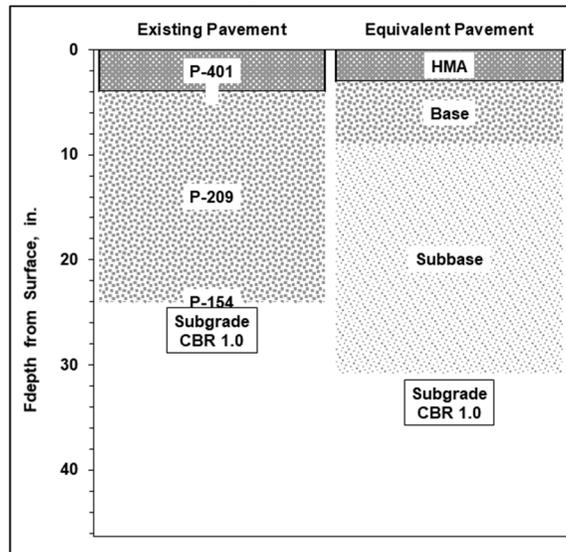
Taxiway Connector E

Existing Pavement Section

4 inch asphalt surface layer
20 inch aggregate base layer
Subgrade CBR 1
